Huonville to Franklin Foreshore Shared Pathway

Feasibility Study

Huon Valley Council

30 October 2019

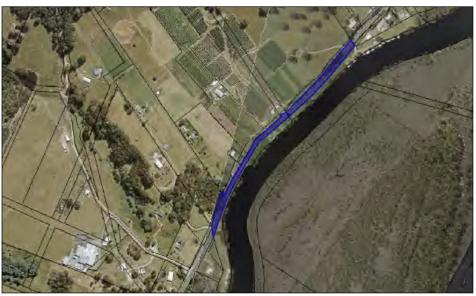
Figure 2 Sections of the public reserve encompassing sections of the Huon Highway

The reserve is comprised of multiple parcels with some extending inland to incorporate the Huon Highway as shown in Figure 2. Although the likely alignment is mostly well separated from the highway, there is one section opposite 3128 Huon Highway where there is limited land available for path location. The availability of land is a limiting factor in this location. These constraints are shown on the overall map of the reserve provided in

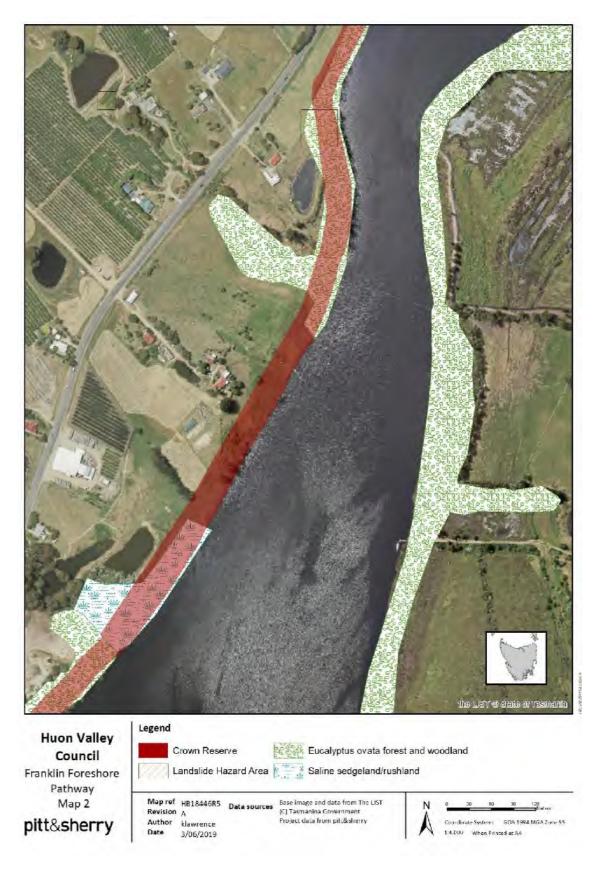
Figure 4 Environmental constraints impacting the reserve

There are no proclaimed Landslip areas within the study area. Two sections of Low Risk landslip cover a small section of the study area, however, these are unlikely to be a significant constraint on the alignment and no specific assessment will be required for the planning assessment. The area affecting the reserve is shown on Figure 4.

There are seven mapped occurrences of the threatened vegetation community *Eucalyptus Ovata Forest and Woodland* within the reserve. This community (see Plate 5) is listed on Schedule 3 of the NC Act. These are identified on Figure 3 to Figure 7 and may affect site specific locations of the alignment. The main areas are located on the southern extent of 38 Coolstore Rd, behind 2279 and 2825 Huon Highway and behind the waste transfer station. The community is fairly

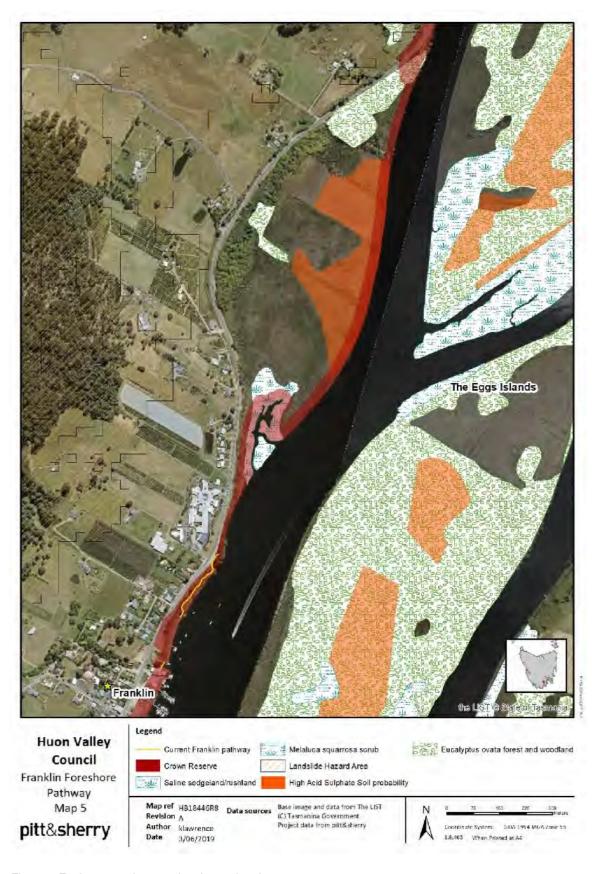
Figure 7 Environmental constraints impacting the reserve

The route generally passes through areas at low risk of disturbance of acid sulfate soils (ASS). One area, in the south of the proposed alignment (adjacent 46099/1) is mapped as being at a high risk of disturbance of ASS (shown red on Figure 6 and Figure 7 below). Construction in areas of potential ASS present a risk associated with the disturbance of sediments which create acidic sediments upon exposure to air. If construction in this area does not involve excavation of sediments, or disturbance and placement above the water table, this poses only a minor risk. This will need to be considered in the context of the pathway alignment and the construction techniques proposed in this area.

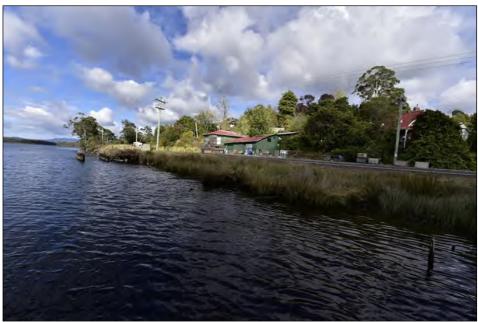
In addition to this area, there are sections of the highway which are located very close to the river edge. In these areas there is insufficient land for construction of a path, and there is ongoing erosion that is undermining the riverbank.

Plate 6 Proximity of the highway and associated development to the river

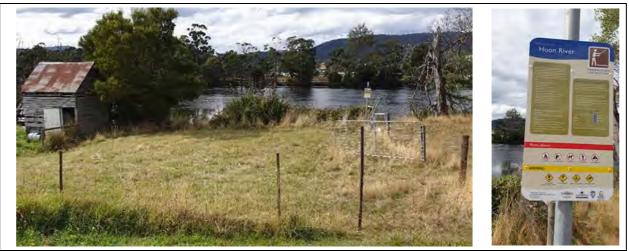
Coolstore Rd provides access to the proposed path start point. This is a sealed road which runs parallel to the river with a formal car park and small jetty located approximately 275 m from the Huon Highway. There is also additional land available at the end of the seal to provide parking / turning areas. There are a number of dwellings located on the landward side of Coolstore Rd. This section is mostly comprised of solid ground conditions suitable to construct a path or boardwalk. The land on the bend in the river contains some wet areas that may require filling or boardwalk. An alternative is to move the path inland, effectively cutting the corner. There is a Telstra submarine cable near the end of this section. There is also a dwelling located approximately 15 m from the reserve boundary at the end of this section.

Plate 7 Existing entry to Crown reserve at the end of Coolstore Rd (looking toward Huonville)

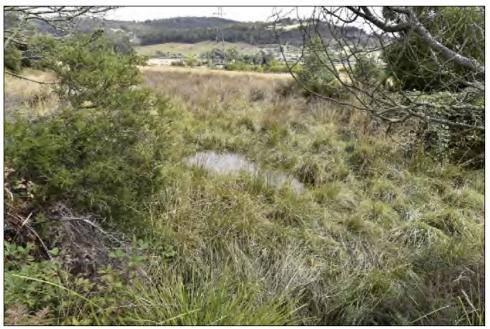
Plate 10 Wet conditions on the river bend make location near the bank difficult

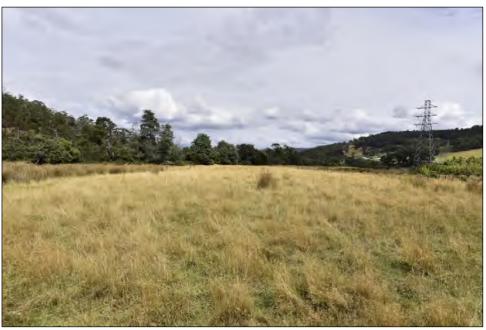
Plate 11 Alternate route to avoid the wet areas on the bend

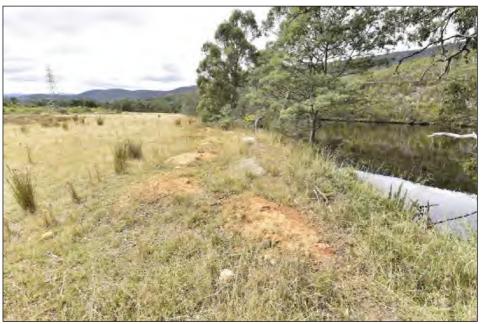
Plate 12 Conditions on the riverbank – previous fill has been placed in some areas

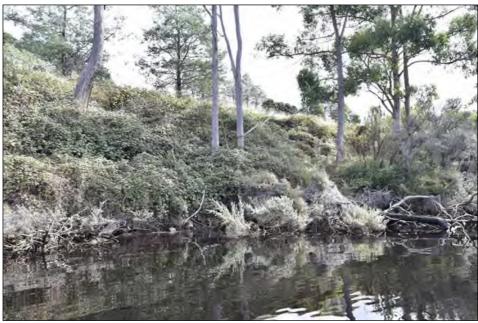
This section follows the outer bank of the river behind 2779 Huon Highway. Following the river edge through this section would require earthworks to batter back the bank and create level ground for path. An alternate route, slightly inland of this section, would follow the slope of the hill and go over the top of the outcrop in the area shown in Plate 14.

Plate 14 Blackberry and native vegetation growth on the riverbank which is quite steep

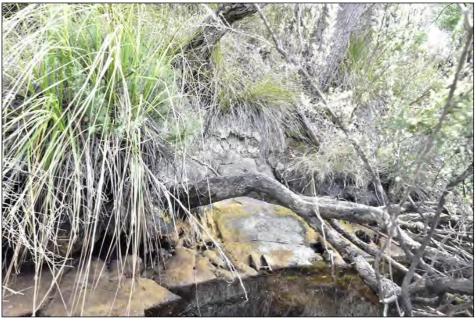
Plate 15 Small rocky outcrops can be avoided

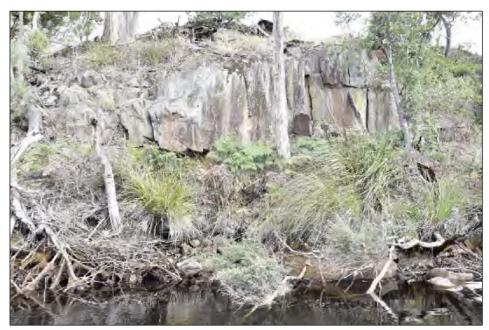
Dolerite outcrops are present in this section and will most likely require rock breaking to continue the route along the river bank. These will provide a solid foundation for construction. Alternately this area could be avoided and tie in to the alternative route recommended for Section 2. There is a dwelling sited approximately 50 m inland from the reserve edge in this section, however, this is largely separated from the reserve by a large dam on site.

Plate 16 Dolerite outcrop

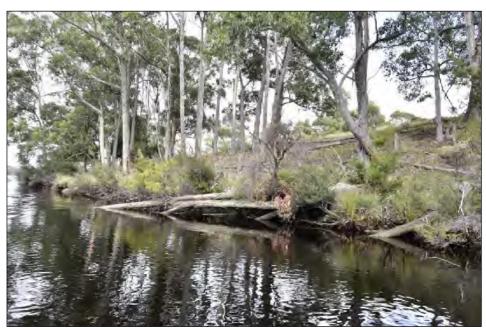
Plate 17 Good conditions for path construction quite close to the riverbank

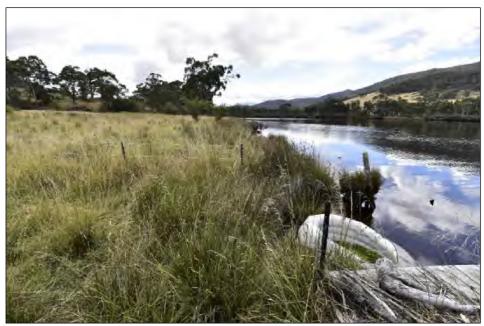
The bank of the river is marshy in places and a setback of 5 m is recommended. There is a dwelling approximately 35 m from the inland edge of the reserve in this section.

Plate 18 Sedge vegetation immediataly adjoining the bank

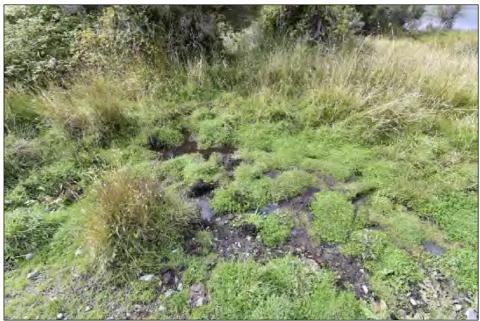
This short section is very wet, marshy land, however, is not mapped as a wetland. The extent of ground moisture, during the dry survey conditions, suggest there may be a natural spring on site. A boardwalk will be required to traverse this section and to prolong the life of the pathway by avoiding constantly wet conditions.

Plate 21 The spring area which causes wet conditions within the alignment area

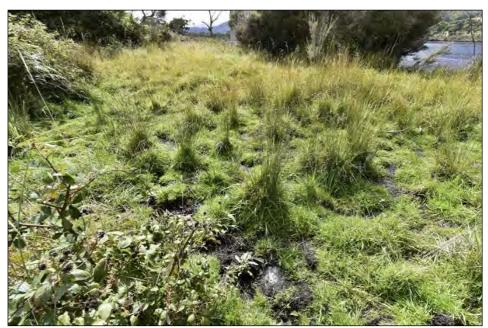
Plate 22 Boggy conditions resulting from the spring

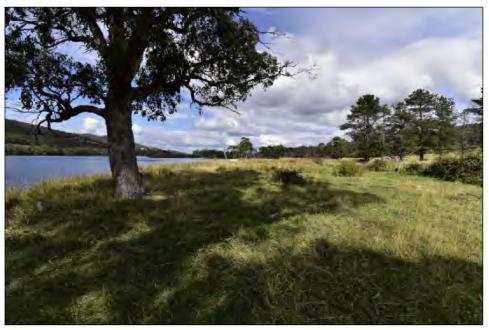
Plate 23 Better conditions for construction within this section

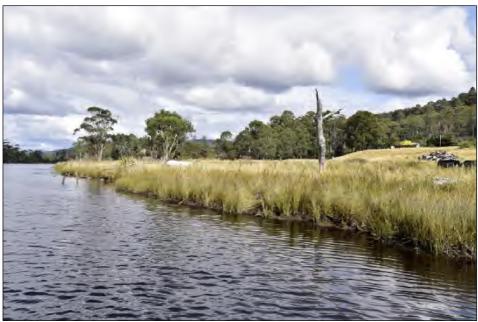
This section is identified as sedgeland on the TASVEG mapping, however, provides reasonably solid foundation once more than 5 m from the bank.

Plate 24 Suitable location and foundation for the path

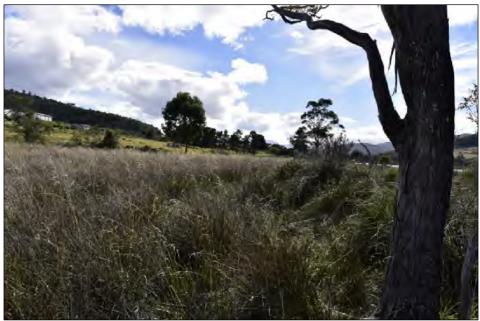
Plate 25 Denser sedges nearer the riverbank

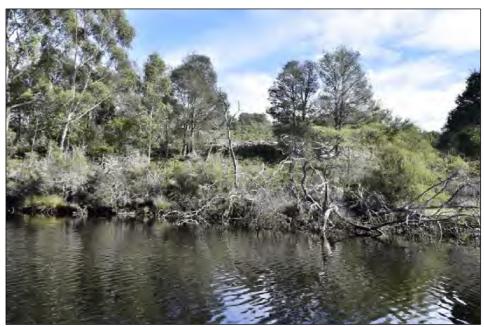
This section passes behind the waste transfer station and the informal yacht mooring area behind 2925 Huon Highway. There are abandoned car bodies within the reserve which will require removal. This section provides good ground conditions for its full length.

Plate 26 Relatively open level ground for path construction

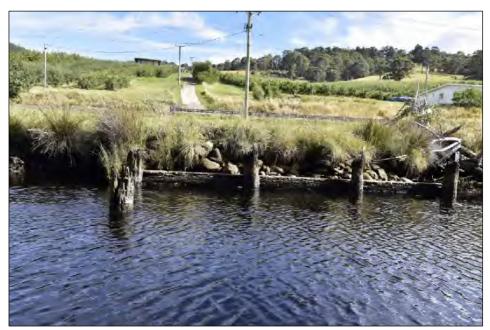
This section is narrow at its northern end and accommodates the powerlines to the dwellings and transfer station adjacent Section 7. The area was very overgrown in places and visibility and access to assess the ground conditions was poor. The stays for the power poles also intrude in to the reserve area. There is a concrete slab from an old shed or dwelling located at the southern end of this section.

Plate 28 Powerlines and previous retaining works within the narrow portion of this section

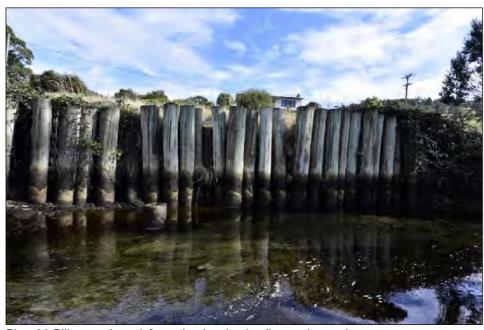
This section follows the outer bend of the river and has been subject to previous erosion. Sheet piling has been installed in the past and further bank stabilisation and back filling will be required. The path will need to be constructed on concrete piles through this section or boardwalk construction used to avoid anchoring any works to the bank.

Plate 29 Piling used to reinforce the river bank adjacent the road

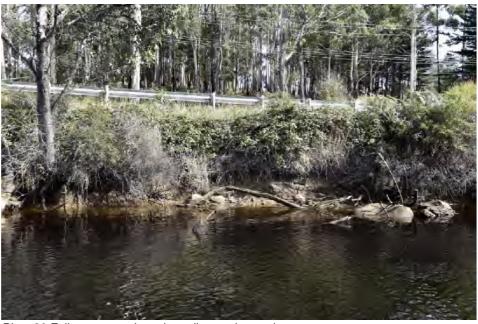
Plate 30 Fallen trees and erosion adjacent the road

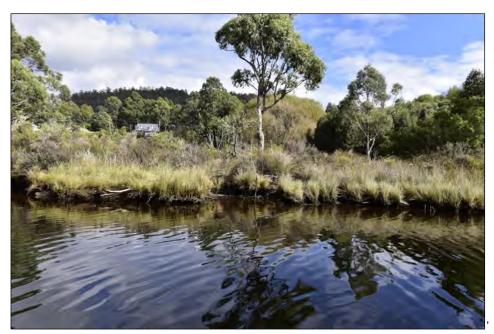
This section provides mostly good conditions for construction. However, the bank may need erosion protection in some areas.

Plate 32 Level ground close to the river offering unimpeded views

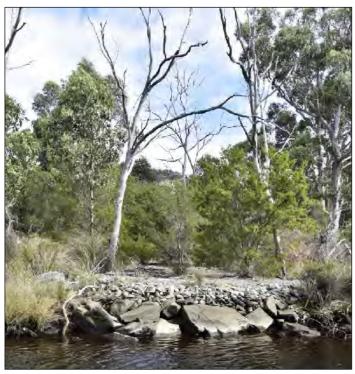
Plate 33 Good conditions for construction are present in this section

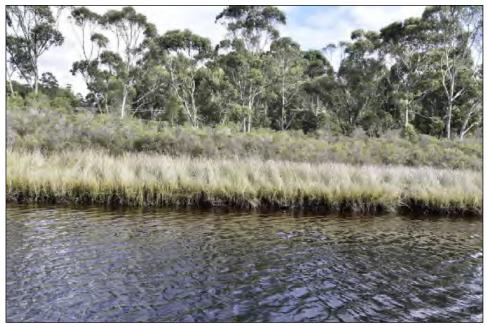
This section passes through level ground, however, a significant portion is through wetland vegetation which offers no suitable foundation for a concrete or gravel path. A board walk will be required across wetter areas and a bridge across Clarks Rivulet. An alternative route could be provided along the road however views would be obscured by development and the path would leave the reserve. There is a strip of acquired road adjacent the highway which suggests future road widening, which would likely make this route unviable.

Plate 34 Areas within the reserve are dominated by wetland

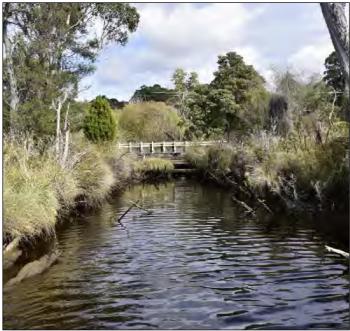
Plate 35 A bridge is required over Clarks Rivulet

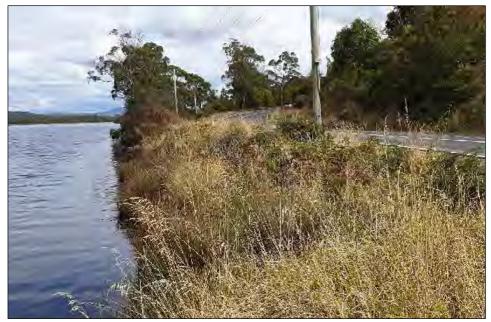
Due to the proximity of the Huon Highway to the edge of the river, the path will need to be constructed in the river throughout this section.

Plate 36 Proximity to the road limits the area available for construction

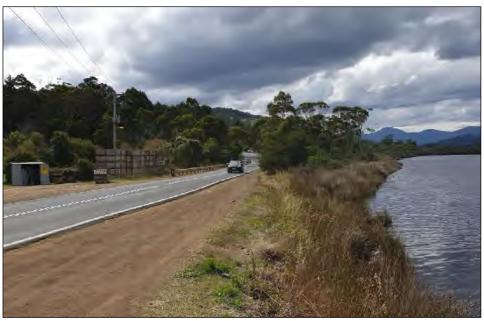
Plate 37 Close proximity to the river in an area used for parking by customers of the cidery opposite

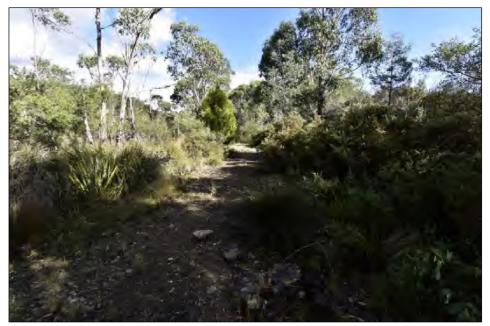
This section offers good conditions for path construction along its length. There are existing informal paths present in this section which may offer a suitable alignment.

Plate 38 Existing path through this section

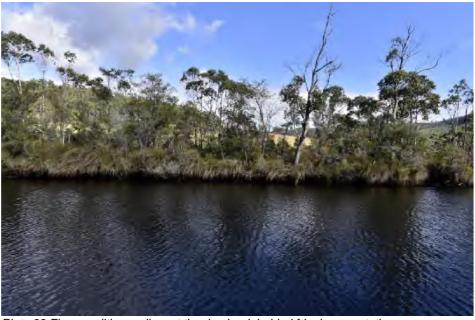
Plate 39 Firm conditions adjacent the riverbank behind fringing vegetation

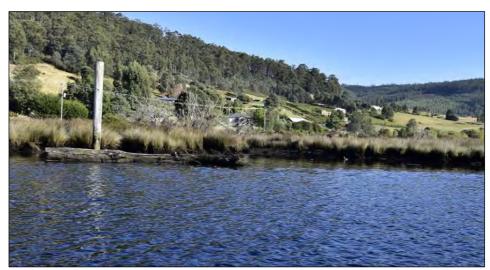
This section follows the outward sweep of the river and is dominated by dense marshy wetlands. A boardwalk will be required to prevent damage to the wetlands and as there is no feasible alternative method of construction. Bridges will be required over the narrow inlets draining from the wetland. An alternative route could be provided along the road, however, views would be obscured by road-side vegetation and the distance from the river and the wetlands would make this section less appealing to pedestrians. There is also a substantial fall from the road which may make construction of a path difficult. This section ties in to the end of the existing path.

Plate 40 Substrates are muddy and support sedge communities. There are some abandoned structures present

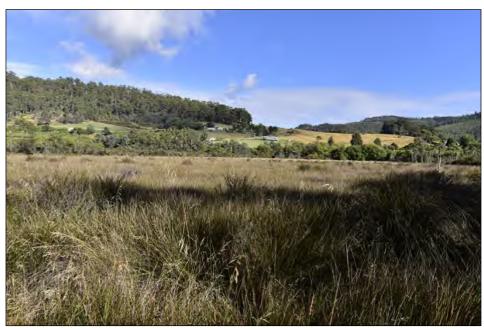
Plate 41 This section is dominated by sedgeland

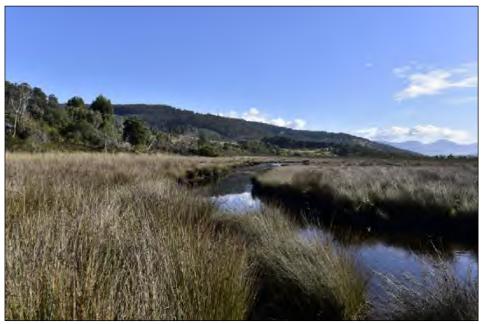
Plate 42 Channels through the sedgeland will require bridges to cross

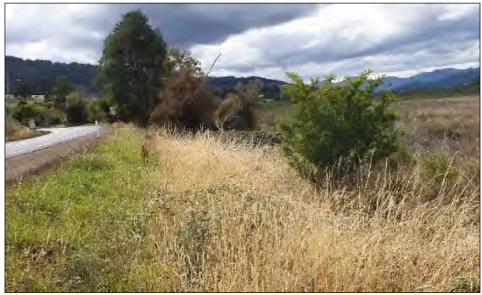
Plate 43 The alternative route along the highway poses its own problems for construction

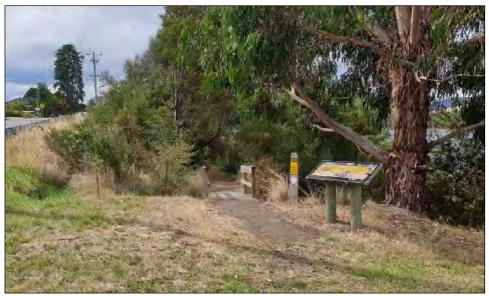
This final section involves the existing path. Sections of gravel path would be upgraded and suitable clearance under trees for cyclists would be required.

Plate 44 Entrance to the existing path

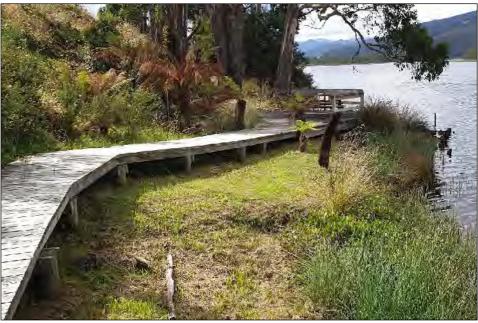
Plate 45 The current path is constructed of treated pine

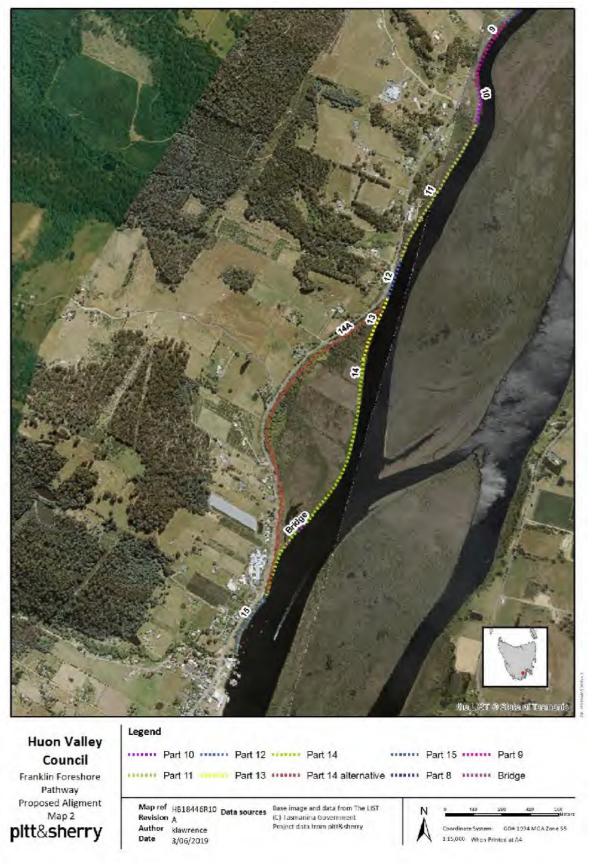
Figure 12 Path alignment showing individual assessment sections (southern portion)

Fourteen distinct sections were assessed for path construction, not including the section of existing path north of Franklin. These are identified on Figure 11 and Figure 12 and have a combined length of 6.75 km (including bridges).

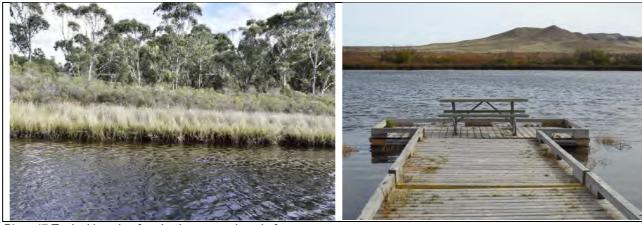
The rowing course runs parallel to the southern sections of the proposed alignment. The construction of the path on the outer edge of the sedgeland presents an opportunity to incorporate casual viewing decks for regattas as well as general recreational use as shown on Figure 15. These could be extended from the boardwalk similar to the example shown in Plate 47.

Plate 47 Typical location for viewing or seating platforms

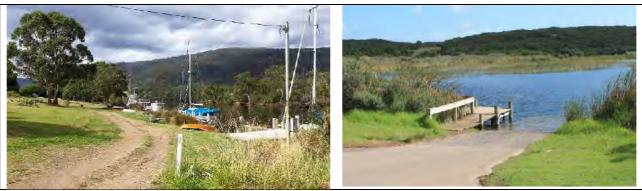
Plate 48 Potential location for kayak landing and suggested simple launching deck and ramp

The Huon River is popular with kayakers and the possibility of providing a launch point was considered. There is an area of yacht moorings on the river side 2925 Huon Highway which is accessed via a road within public land (shown on Figure 14). There is also sufficient area for maneuvering and parking of vehicles in this area. The land has an area with suitable slopes for a ramp or a jetty similar to the one shown in Plate 48.

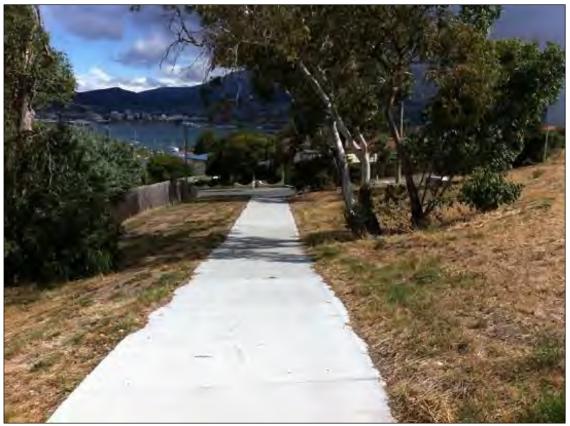
Plate 49 Typical concrete path - Tasman Bridge to Rose Bay Highschool

Concrete path is recommended for 3.45 km, or just over half, of the 6.75 km total length (Plate 49 and Figure 16). Costings are provided for 2 m and 2.5 m widths.

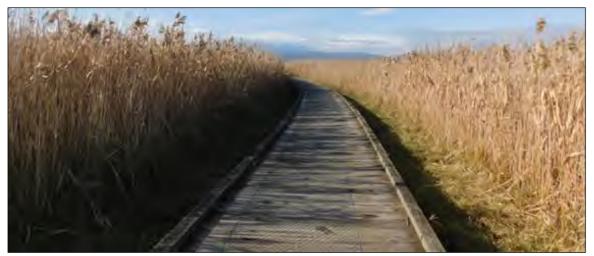
Plate 50 Example board walk with side rail and slip prevention wire (from Tamar Wetlands)

Boardwalks are proposed over large sections of the alignment where ground conditions are not suitable for concrete path construction, where vegetation communities or bank erosion require avoidance or where there is insufficient land available between the road and the river. These would be constructed of treated pine superstructure with either treated pine (Plate 50) or fibre glass reinforced plastic (FRP) as shown in Plate 51. FRP is well suited to wet or corrosive environments and provides inherent grip, eliminating the need to install wire mesh for slip protection. Costs for superstructure is the same for both with the reduced cost for installation of FRP deck panels (as opposed to individual planks) reducing the overall costs.

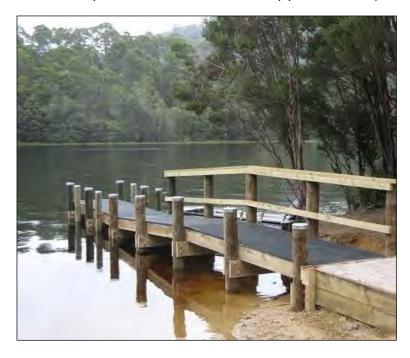
Plate 51 Example jetty with FPR surface and pine superstructure (Source: Grating Tasmania)

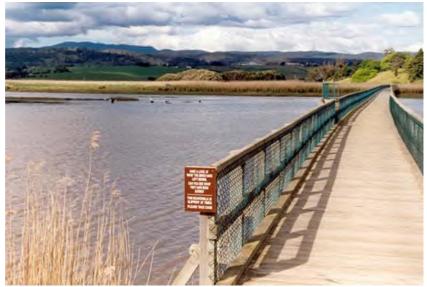
Plate 52 Example bridge

Short sections of bridge are proposed across inlets and Clarks Rivulet. These will be similar in construction to boardwalks and may include side barriers. Depending on water depths and location it may be possible to simply extend boardwalks in lieu of bridges. An example is shown in Plate 52.

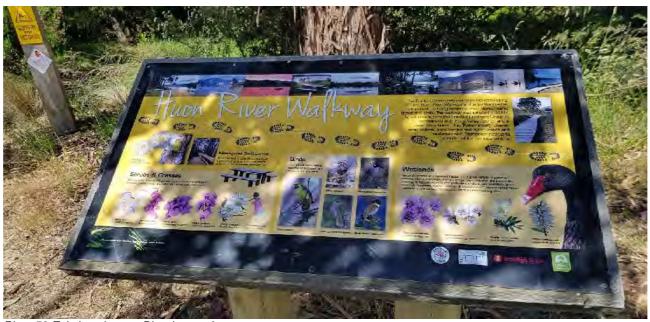
Plate 53 Existing signage Bicycle stand

The installation of signage at either end is recommended to identify key features of the path such as length, access requirements and timeframes for completing. Details of facilities (seating, kayak landing, etc) and their location along the path could also be included. Signage along the path to highlight natural values (as per the existing signage below) can also widen the user experience.

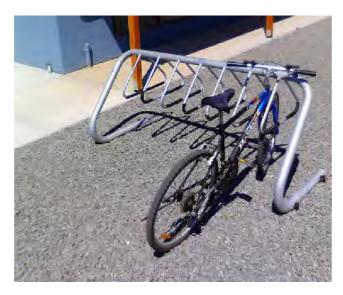
Plate 54 Simple bicycle facilities

Optional bicycle stands could be provided at the commencement of the path head and at locations along the route.
